Efficiency Actions in the 4 Water Utilities of Pátzcuaro Lake, Michoacán, México

Antúñez Leyva E.¹, Rodríguez Varela J. M.¹, Casados Prior J. A.¹, Gómez Lugo L.¹, Hansen Rodríguez M. P.¹, Blanco Ortega A.²

1. Mexican Water Technology Institute (IMTA), México

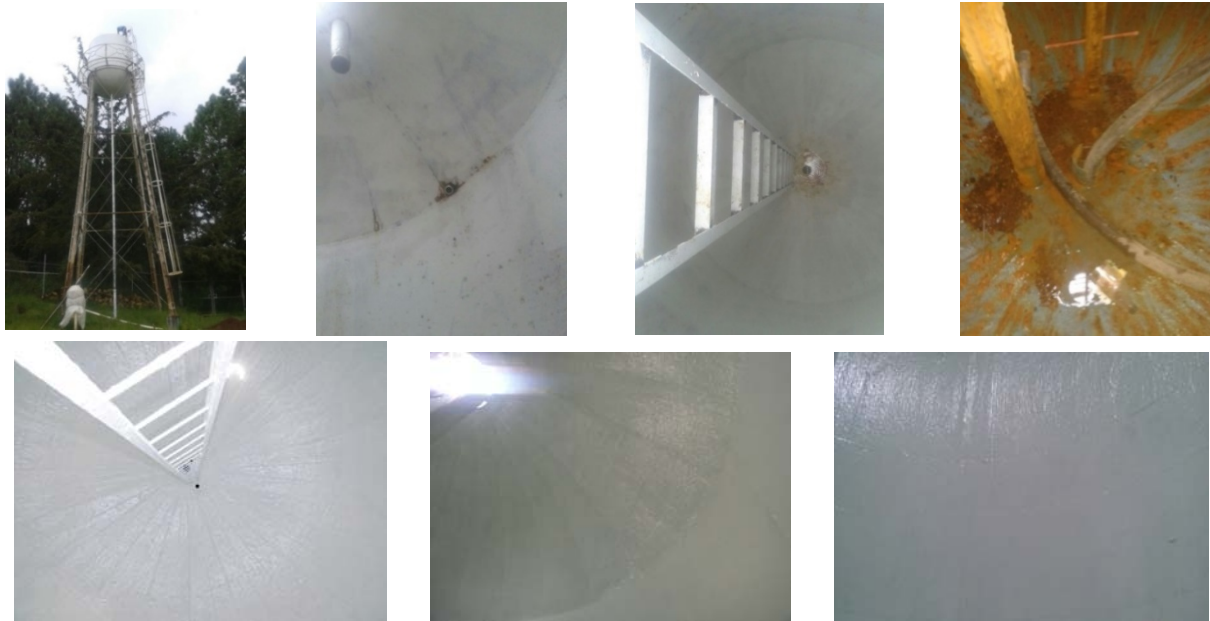
Fig. 3 Rehabilitation of metallic tanks with VITROACERO® (Concluded work).

storage tanks (metallic and masonry): Storage tanks are the principal junction of any hydraulic network, nonetheless, the lack of a maintenance program as well as economic resources has given rise to several coastal tanks of Pátzcuaro Lake currently having considerable fissures that generate the leak of potable water, a natural resource which has had electrical energy invested in it for its extraction and piping along with man-hours and chlorination. On top of this, there is a negative impact on the image of the water utilities as a result of the leaks and waste that result from absent rehabilitation. In the first phase, tanks that had immediate potential to be rehabilitated without major work or adaptations were repaired. Fig. 3 and 4 show the works carried out on the elevated metallic tanks and a superficial masonry tank as well as a scanned guarantee of the works expedited by the company that provided the repair services (Fig. 2).

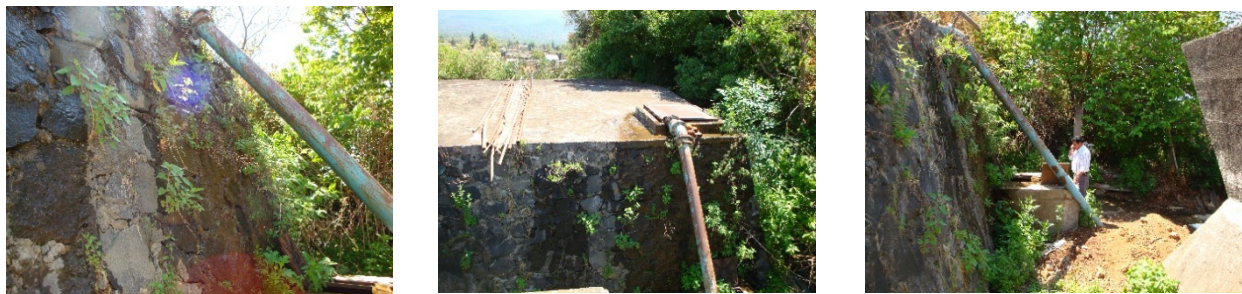
Fig. 4 Rehabilitation of masonry tanks with VITROACERO® (concluded work).

Tank with multiple fissures responsible for potable water waste

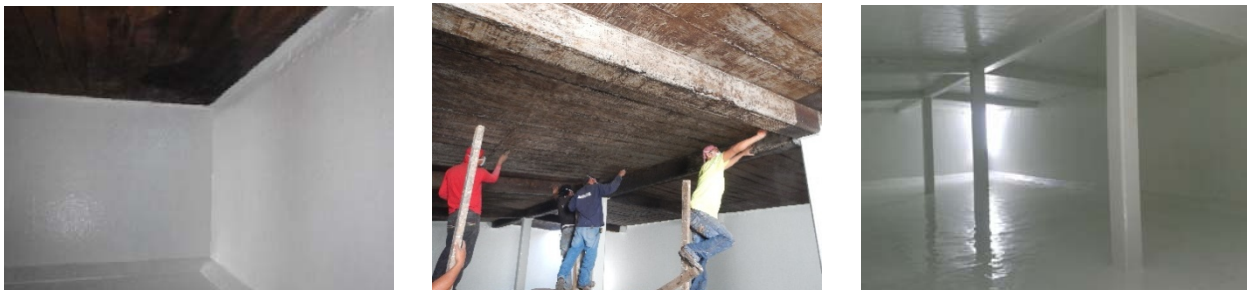
Rehabilitation Works to prevent the leak of water in The Superficial tank in Erongarícuaro, Michoacán, México.

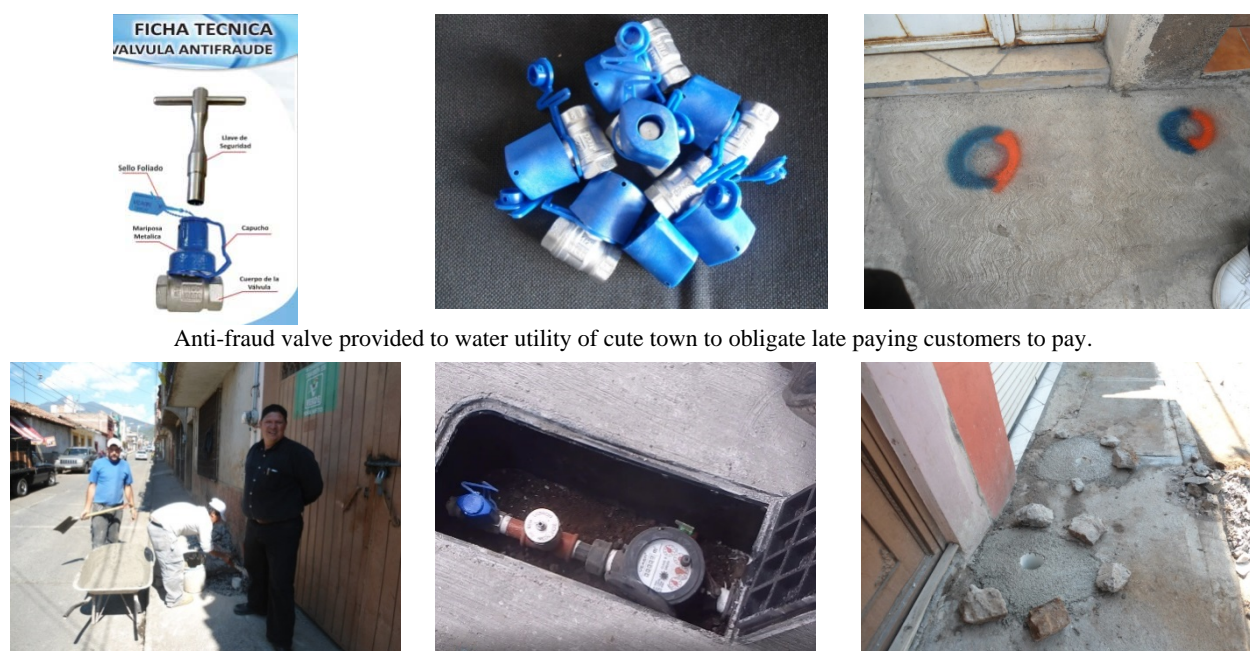
Fig. 5 Provision of multi-closing, anti-fraud valves, installed by water utilities (concluded work).

to clients, these valves were provided to the water utility in order to obligate past-due clients to proceed to the utility offices to make their timely payment. This

measure is intended to fortify the collections mechanism of the water utility. The anti-fraud valve that is shown here has the advantage that it cannot be

manipulated by the user, hence its commercial name. The installation was carried out by the water utility as shown in the images of Fig. 5.

Anti-fraud valve provided to water utility of cute town to obligate late paying customers to pay.

Installation of anti-fraud valves by water utility personnel for late-paying customers.

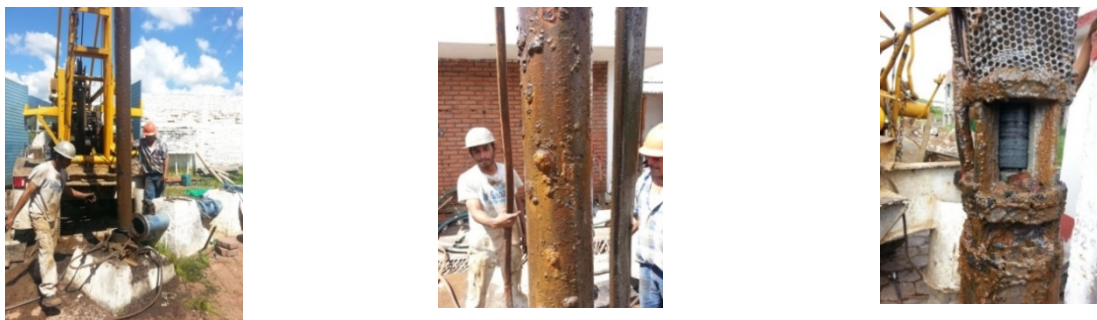
Fig. 6 Diagnostic video inspection of five coastal wells of Pátzcuaro Lake.

Evaluation of the electromechanical infrastructure and video inspection of five deepwells. Result: rehabilitative actions budgeted: The scope of these works was to determine the actions needed to rehabilitate five deep wells found on the coast of Pátzcuaro Lake through the evaluation and diagnostic of the electromechanical infrastructure as well as the video inspection of the well. Finally, as deliverables, the IMTA provided a report with the rehabilitative actions that each one of the five wells need, including the specification for their execution and budgeting so that they receive consideration in the Annual Works Program for the year 2016 by the State Water and Basin Management Commission (CEAC) for the State of Michoacán. Fig. 6 shows some images of the works performed on the deep wells, including, measurement of the electrical and hydraulic parameters, video inspection of the inside of the well, evaluation of electrical system, identification of rehabilitative actions and budgeting.

Extraction of pumping equipment in well number one in Quiroga to introduce video-inspection camera.

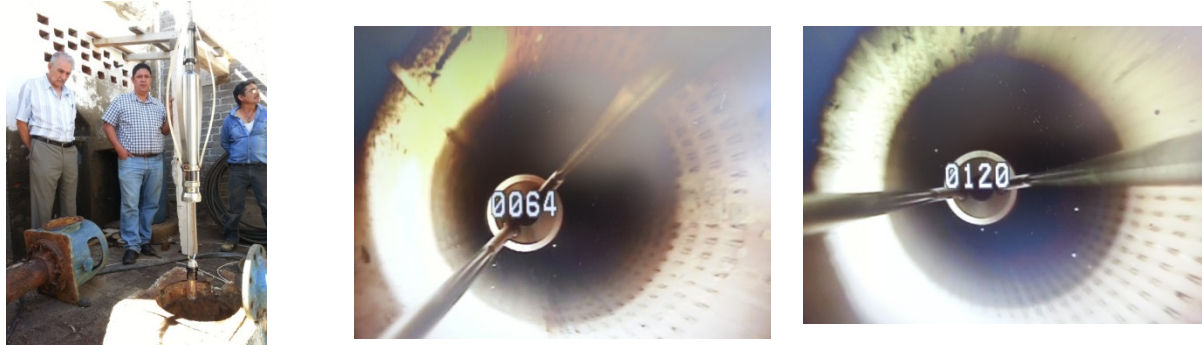
Interior well inspection to determine conditions and propose rehabilitative actions.

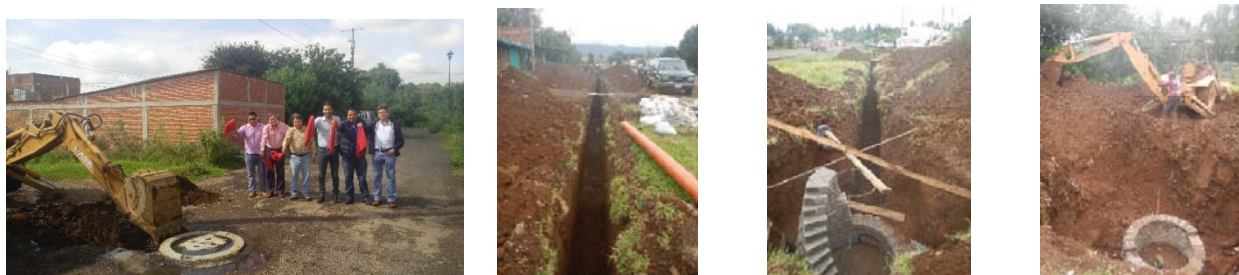
Fig. 7 Beginning of rehabilitative drainage works and their construction process.

of the Erongarícuaro-Pátzcuaro Highway: In June of 2016 the CEAC validated the projects performed by the IMTA, the municipality of Erongarícuaro and the CEAC and convened to have these drainage works done in the town of Erongarícuaro. At the end of the month of June, the CEAC began drainage works that correspond to the rehabilitation of the drainage of the San Antonio and Ma. Luisa Martínez residential areas as well as Km 1 on Erongarícuaro-Pátzcuaro Highway all of which are in Erongarícuaro and concluded at the end of the month of September. Fig. 7 shows images of the works done.

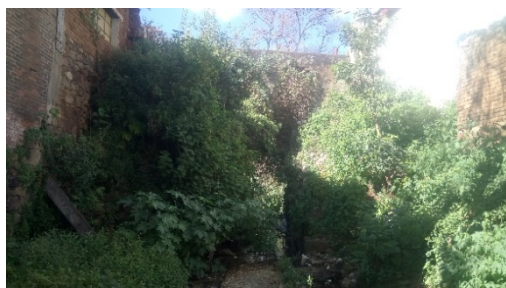
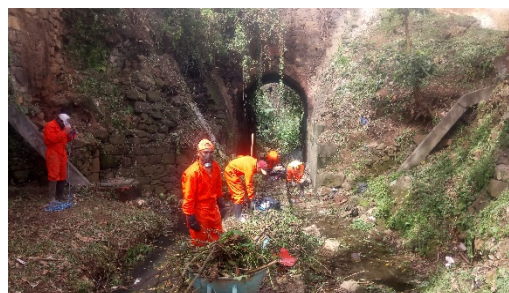
Stretch 2: Pueblita St. - Ahumada bridge

Fig. 9 Cleanup and weed removal of three stretches of the Guan River as well as its slopes (2.1 km).
