Environmental Sustainability Evaluation Method in Public Works Audit: Analysis of the Maciço do Morro da Cruz, Florianopolis, SC, Brazil

Alessandra Rodrigues Vieira de Castro¹, Anna Paula Rodrigues², and Orlando Vieira de Castro Junior³

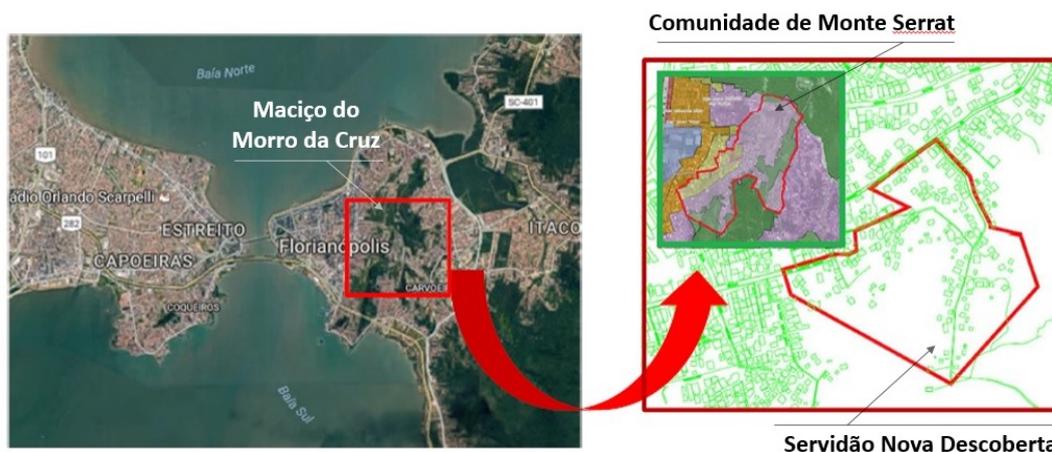
Fig. 1 Left: Maciço do Morro da Cruz view (red square), in Florianópolis, SC; Right: Monte Serrat community (green square) and Nova Descoberta Street (red polygon).

The study site selected for this research was a street called Nova Descoberta within Monte Serrat Community, one of the 18 tenements in MMC (Fig. 1). Nova Descoberta Street is in an environmentally vulnerable area, designated as a Limited Use Preservation Area (or APL in Portuguese acronym) by the Brazilian Forest Code.
