The Preservation and Restoration Project of the Castello dei Paleologi in Casale Monferrato (Alessandria): The Works on the External Wall Surfaces of the Northern Bastions

Giorgia Gentilini

Free Lance Architect, Italy

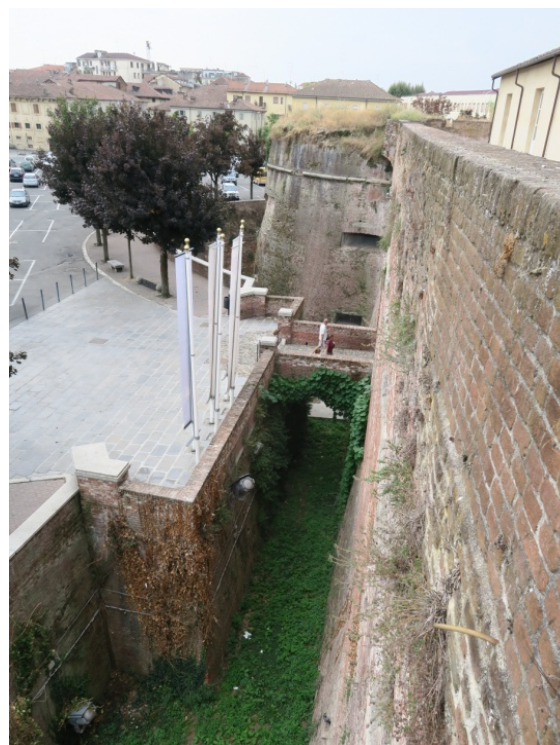
Fig. 1 View from the north of the south-east bastion, of the eastern curtain and of the counterscarp of the moat.

The Eastern front of the fortified system, which is the object of the intervention, heads towards the urban core of the historical centre, for which it represents a prestigious backdrop. The eastern prospect is almost 84 meters long, of which 37.5 meters for the central curtain wall and 23 meters each side for the two bastions closing it to the north and to the south: the height of the curtain and of the bastions varies between 14.5 and 15 meters.

coping diameter about 20 meters. The wall thickness varies between 6.5 and 8 meters. The thickness of the eastern central curtain is inferior, 3.85 meters. The boundary walls feature an inclined scarped profile, particularly marked in the bastions. The brickwork support structure is separated from the coping with the battlements of the parapet by a rounded cordon made from sedimentary stone: the curtain instead features a brickwork cordon closing the scarp and a rectangular profiled cordon reconnecting with that of the bastions. The wall curtain, in its articulated stratification, is a good evidence of the size and complexity of the continuous changes the Castle has been undergoing in the course of time. In particular the eastern front houses the main entrance to the fortification which retains some traces of its XV century look. The access to the first inner court (the most ancient core) is defined by a round-arched portal with a frame in relief made from brickwork elements and featuring two coat of arms, the bigger of the two showing the arms of the Gonzaga and Paleologi families and the smaller the ancient arms of the Gonzaga family. Above the entrance portal the lifting system of the drawbridges is still well visible, featuring huge housings for the beams for the main entrance and for the small entrance door of the pedestrian passage, to the right of the main door. Inside the walls two square adjacent courts are present, separated by a central corridor developing towards north-south.

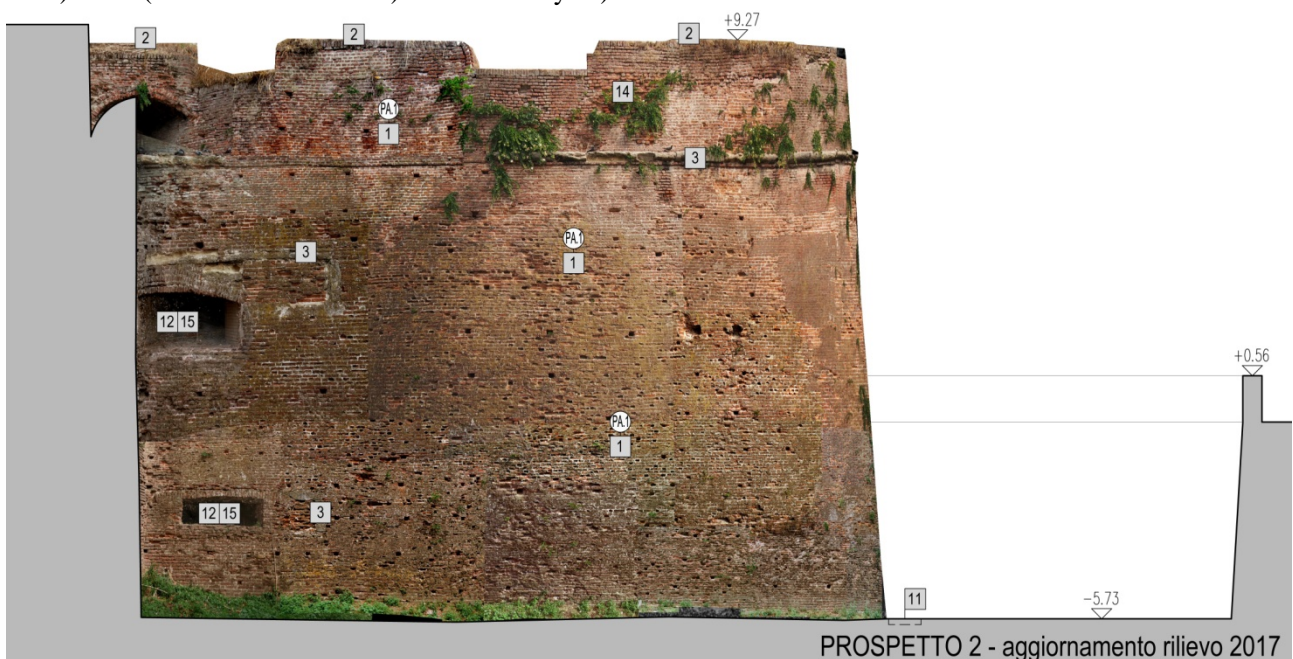
Fig. 2 Project table of the north-east bastion with counterscarp of the moat.

In order to prevent the vegetation with roots to get nearer to the prospects with brick face of the south-east bastion, of the eastern curtain, of the north-east bastion, a 90cm. wide stripe of gravel flooring is foreseen after mechanically lowering the soil by 15 cm.
