# Mapping and Analysis of Environmental Risks in Dr. Luzardo Ferreira de Melo Street, Jauary- I, Itacoatiara-AM

Carla Eloiza Bavose Campos Seabra, Samara Pereira de Freitas, and Natália Pereira de Freitas

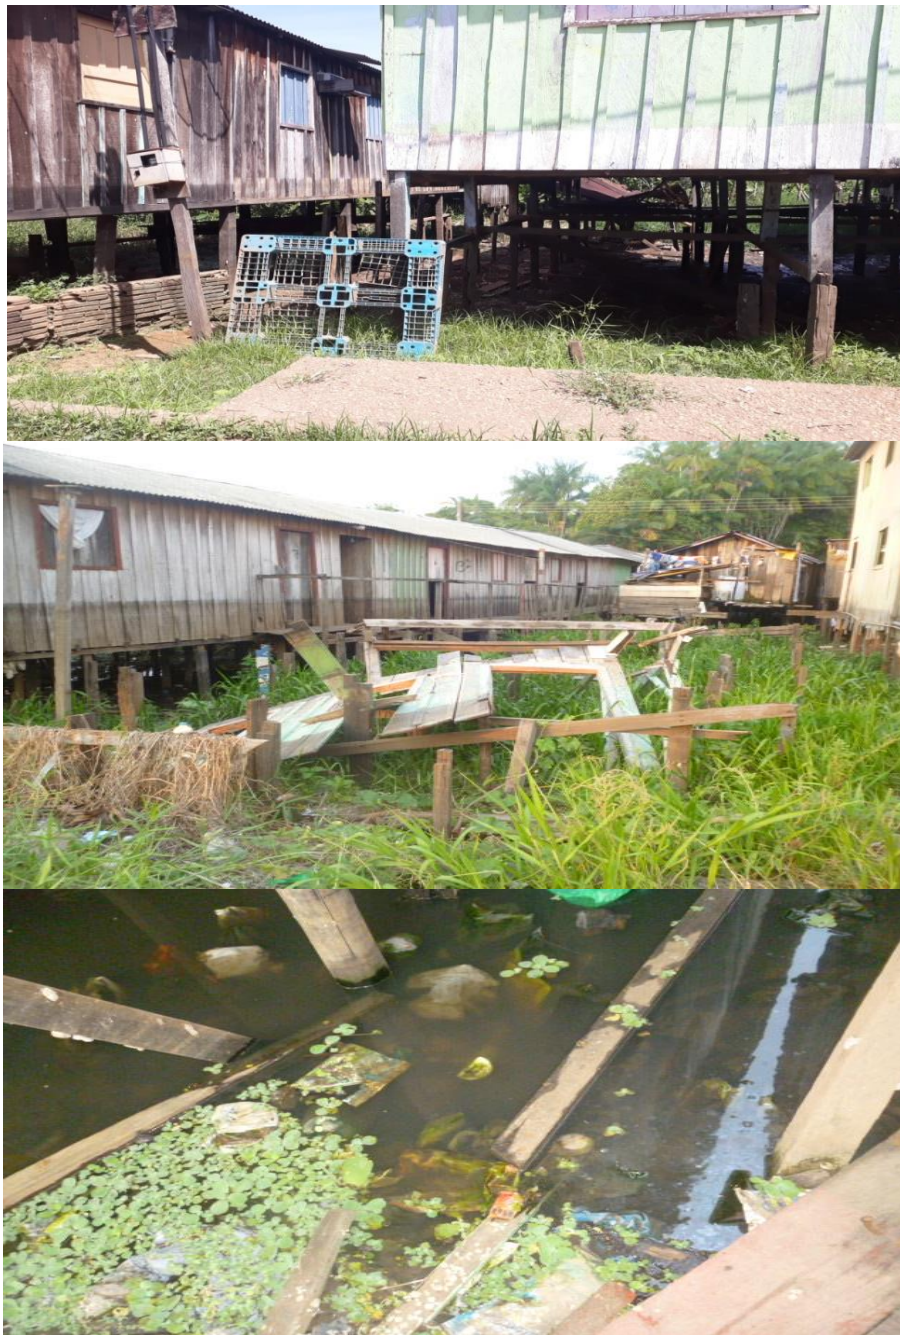
The research was carried out through a technical visit at the site (see Fig. 1). There were surveys and bibliographical revisions accompanied by some

**Fig. 1** Technical visit to record images of the local's actual conditions: first and second images show the standard of housing construction; the second also presents the marks of the last flood (2018), and the third shows total absence of street sanitation.

Among the 4 existing risk levels: Very high risk (R4), High risk (R3), Medium risk (R2) and Low risk (R1). The Dr. Luzardo Ferreira de Melo Street was classified as: R2, like we can see to the Figs. 1 and 2 and Table 3.

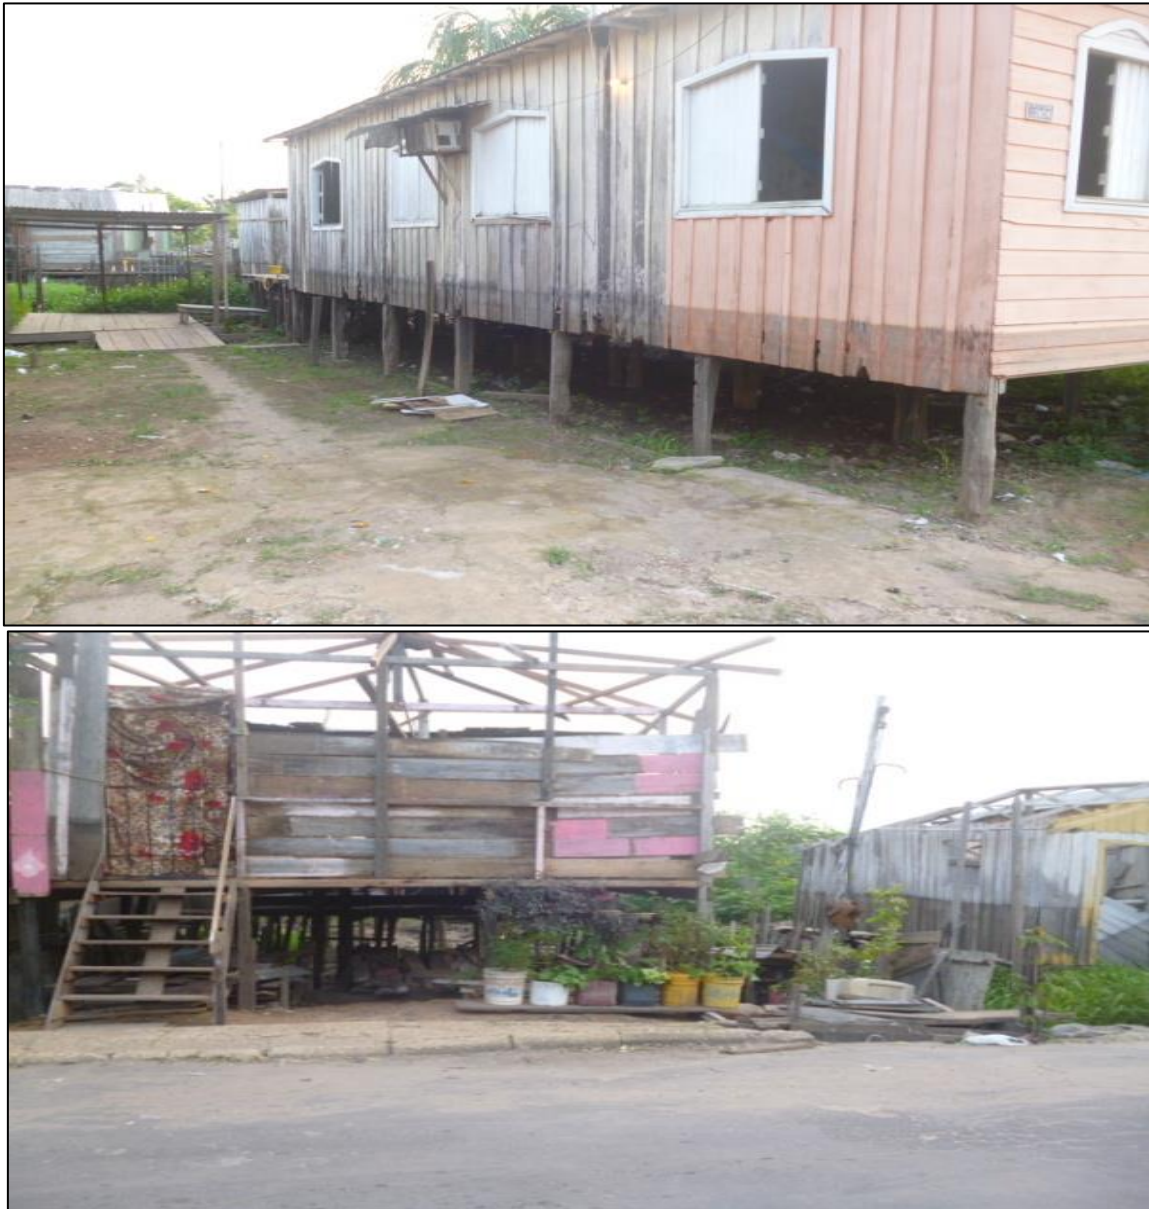
Through the interviews we were informed, by the residents, that they are in this hard situation because they moved to the capital, which before living in small towns, and were unable to choose a safe place to live. Thus, it is resulting into a disorderly occupation of people who came from the interior and built their residence where they got since this are going worse situation each day. They allege difficulties with the infrastructure in general, which gets worse during the period of floods caused by the rise of the river, causing physical and socioeconomic disturbances to all who live in the locality. Residential constructions are marked by rustic features and their main raw material is wood as shown in Fig. 2, which increases their vulnerability to natural phenomena.

As the region is characterized by being a floodplain area due to periodic flooding, its foundation in the ground is made by stilt-shaped buildings, with houses erected 1.5 m to 2.5 m above ground level, with the purpose of mitigate material losses.

**Fig. 2** Technical visit to record images of the local's actual conditions: first and second images show the standard of housing construction; the first shows the poor degree and the instability buildings (at side), and the second also presents the marks of the last flood (2018).
