# Assessment of the Macroscopic Aspects of Córrego das Pedras Sub-basin, in Ouro Verde de Goiás, Goiás, Brazil

Maria Andréia dos Santos Jaime

*Centro Universitário de Anápolis - UniEVANGÉLICA, Brazil*

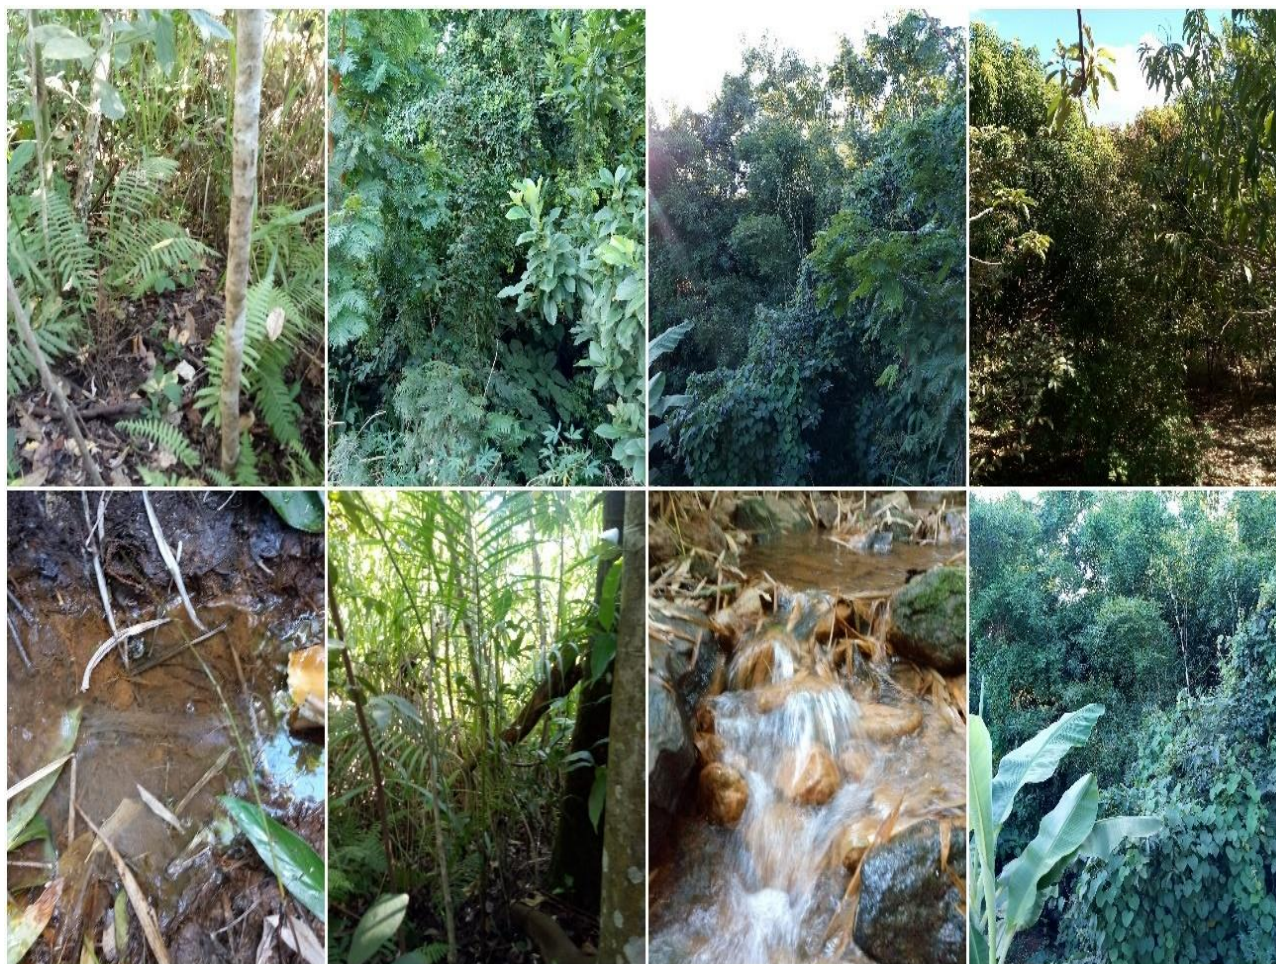
**Fig. 4** Registration of the riparian forest, in 2017, and the surrounding of the spring, with indications of recovery at property P.4. (A) evidence of de-compacted soil, vegetation recovered. (B and C) growth of bushes within the riparian forest. (D) fruit trees that were planted within the riparian forest. (E) area close to the spring, soaked soil. (F) presence of ferns typical of preserved areas. (G) water flow within the riparian forest.

the spring is protected (Fig. 4). In the tree trunks of the riparian forest, which is also fenced, it is possible to observe the presence of lichens, a certain indicator of good air quality. The APP has firebreak system to prevent fire, and it is noteworthy the abundance of water in the area (Fig. 4G). PPARJL's work in this area will be limited to fencing the water course upstream the riparian forest. No waste, floating matter, foam or oil, nor evidence of sanitary pollution in the assessed spring. There are terraces and contour lines to contain rainwater, the roads were not built applying soil conservation techniques. After scoring the parameters, the assessed spring reached IIAN 33, falling into the "A" class, which has an excellent degree of preservation.

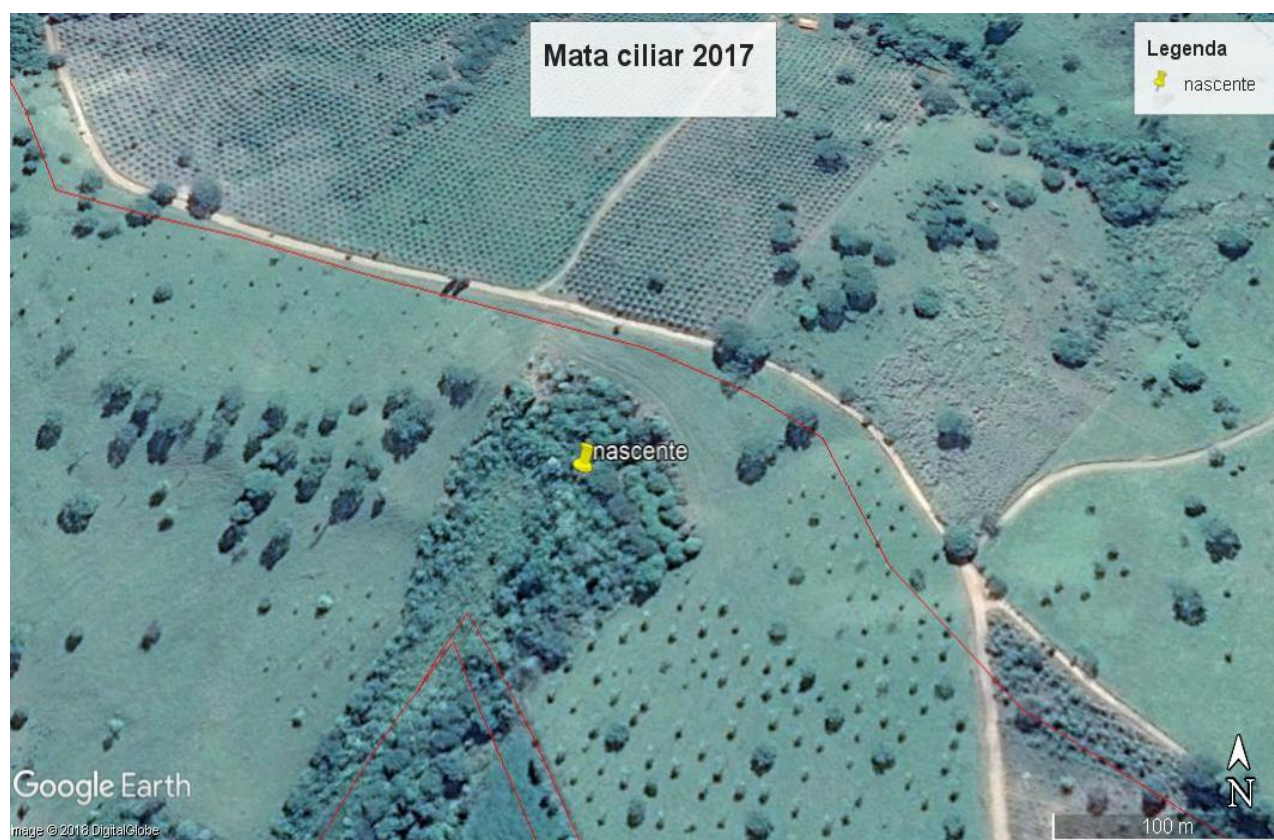
**Fig. 5** (A) Registration of the surroundings of the spring, at property P.04, in 2003. Spring without the presence of riparian forest. (B) Photo from 2017, spring protected and surrounded by a large riparian forest.

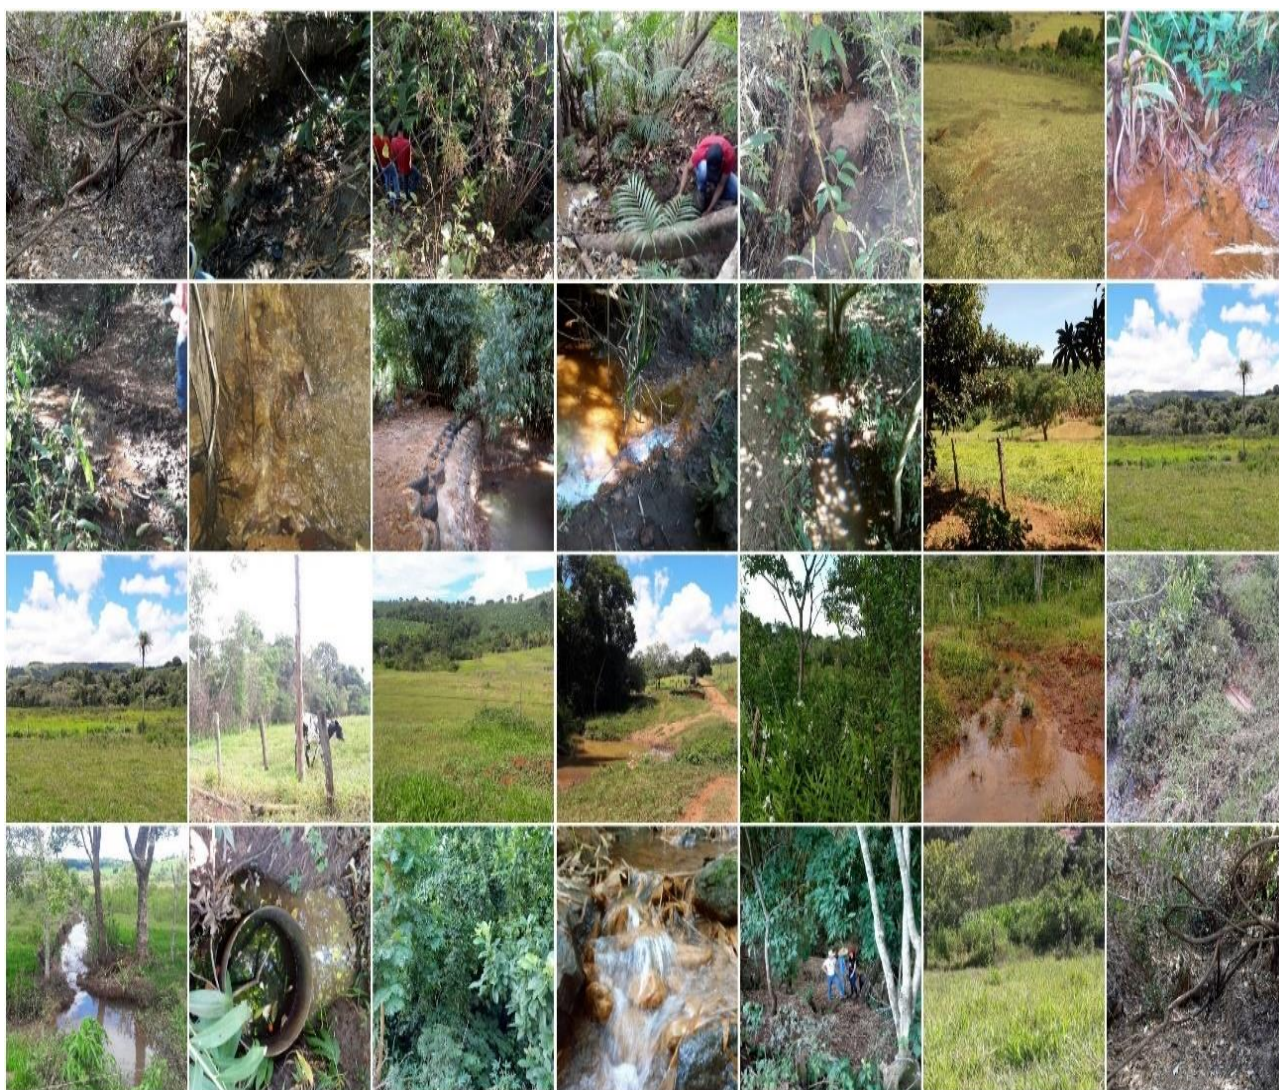
Fig. 6 globally registers the area analyzed in the research, the riparian forests and the surroundings of the springs, showing the positive and negative anthropic aspects.

**Fig. 6** Registration of springs and riparian forest assessed in the Córrego das Pedras Sub-Basin, Ouro Verde de Goiás, state of Goiás. (A) Surrounding of the spring on Property P.14. (B) watercourse that went dry on Property P.14. (C) Riparian forest on Property P.08. (D) spring assessed on Property P.08. (E) spring assessed on Property P.13. (F) spring assessed on Property P.06. (G) spring assessed on Property P.09. (H) spring assessed on Property P.13. (I) spring assessed on Property P.13. (J) stream bed recovered on Property P.07. (K) spring assessed on Property P.07. (L) unprotected water course on Property P.05. (M) riparian forest on Property P.06. (N) surrounding of the spring on Property P.02. (O) surrounding of the spring on Property P.02. (P) riparian forest on Property P.10 with the presence of animals. (Q) surrounding of the spring on Property P.06. (R) Unprotected water course on Property P.02. (S) surrounding of the spring on Property P.12. (T) spring course of Property P.12. (U) spring devoid of riparian forest on Property P.03. (V) unprotected water course on Property P.03. (X) practice of negative anthropic activities in the spring on Property P.01. (X.1) riparian forest on Property P.04. (X2) water flow within the riparian forest on Property P.04. (X3) riparian forest of the assessed spring on Property P.01. (X4) surrounding of the spring on Property P.11. (X5) surrounding of the spring on Property P.14.
