Pathologies on Mozambique Roads, Assessment of Flexible Pavement Conditions

These problems justify the academic purpose of the need to develop the present work, which aims to investigate the conditions of the flexible pavement of National Road Number Two (N2), Boane-Namaacha section, over a length of 2 km, using the PCI method.

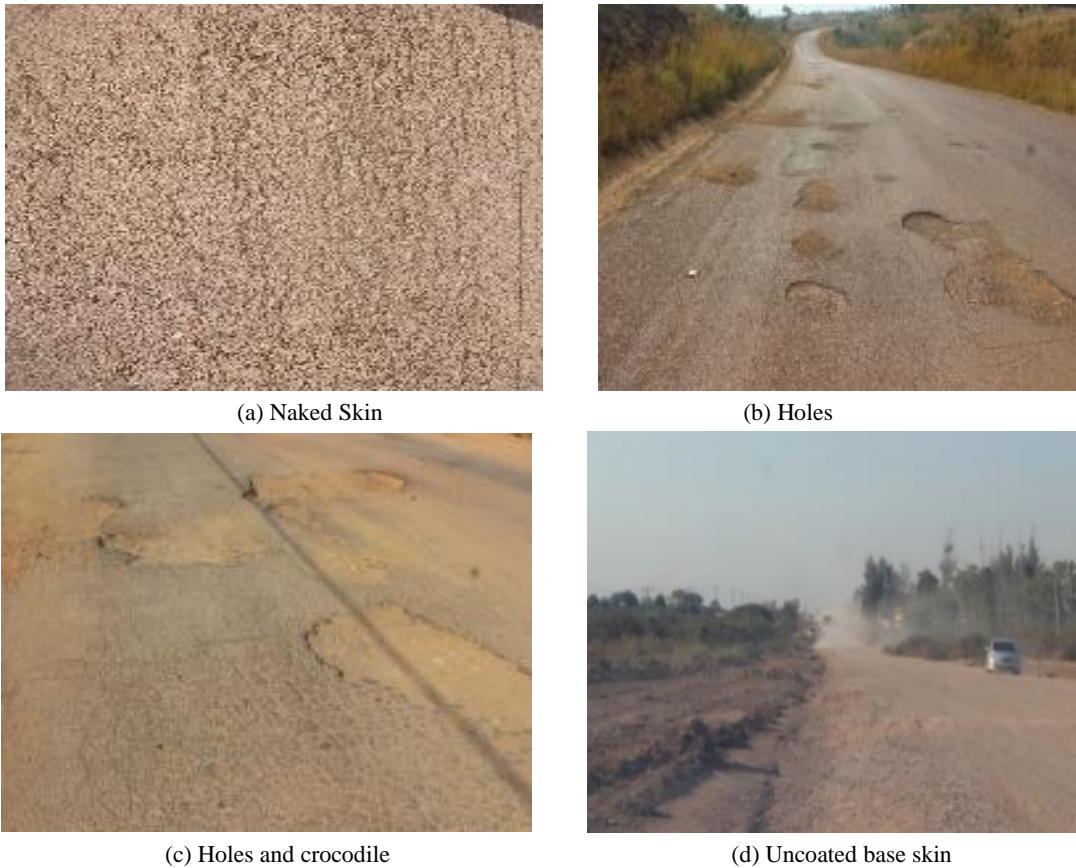
Fig. 2 Road defects.

During the inspection visit to the road under study, the existence of different pathologies was found, namely, crocodile skin, peeling, holes and an uncoated base as illustrated in Fig. 2. During the research, these were found to be causes of degradation on the N2 the poor preparation of the pavement surface, the intensity of traffic, and the lack of load control of heavy vehicles transporting inert materials. The N2 road has annually benefited from routine maintenance that consists of localized maintenance activities to fill potholes, however, it is noted that due to the lack of resources it has not been possible to carry out complete maintenance or rehabilitation, which is considered to be an appropriate option for this case.

Fig. 2 illustrates the pathologies found along the Boane section — Namaacha.
