# Increasing the Safety of Tensile Structures

**Abstract:** An actual issue arising from daily work in the quality assessment of large structures is the safety of structures. Considering the most common failures of membrane roofs we can detect two main causes: either detail failures or failures of the material. To avoid failures of details in Germany, e.g., a quality assurance system for every project is being executed. Testing all structural important details of a structure before and during fabrication confirming the necessary safety factors minimizes risks very effectively. However this does not avoid all problems occurring on site as many failures are caused by harming the material itself. In this paper failures will be shown on which the origin of the problems will be demonstrated: mechanical damages, folding etc. caused during manufacturing, transport and use. The following questions will be discussed: Where do tears come from, how could they be avoided on one hand and on the other hand, in case they have happened: how can we predict the influence on the safety of the structure? Safety reducing aspects and test methods to elaborate the residual strength of materials will be

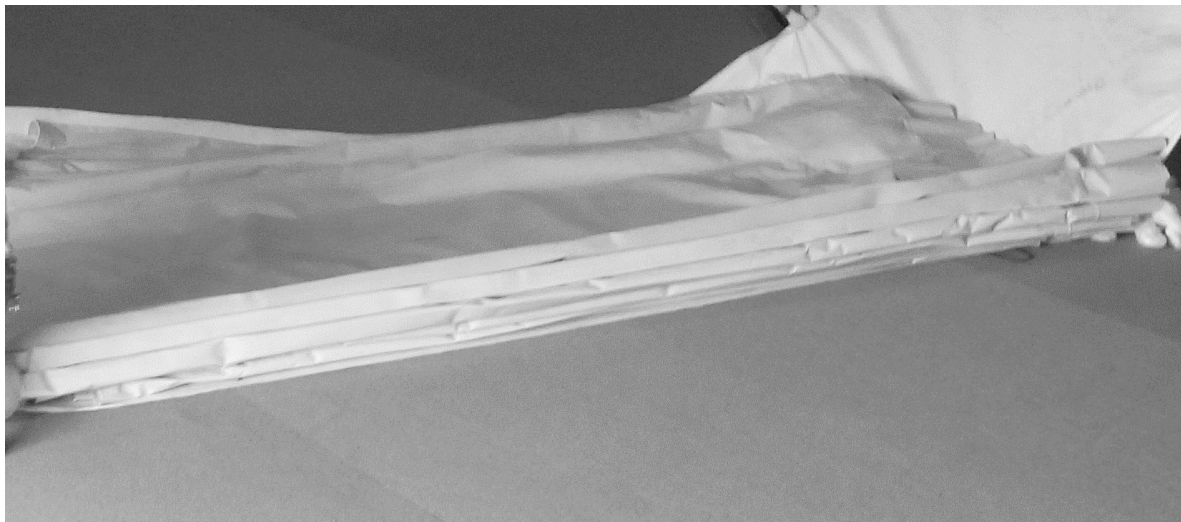
**Fig. 1 Looped material [DEKRA].**

Loops may occur occasionally or where desired and necessary due to limited space for large panels (Fig. 1).

As soon as these loops are loaded with more loops and material or due to inattention a sharp crease may happen.

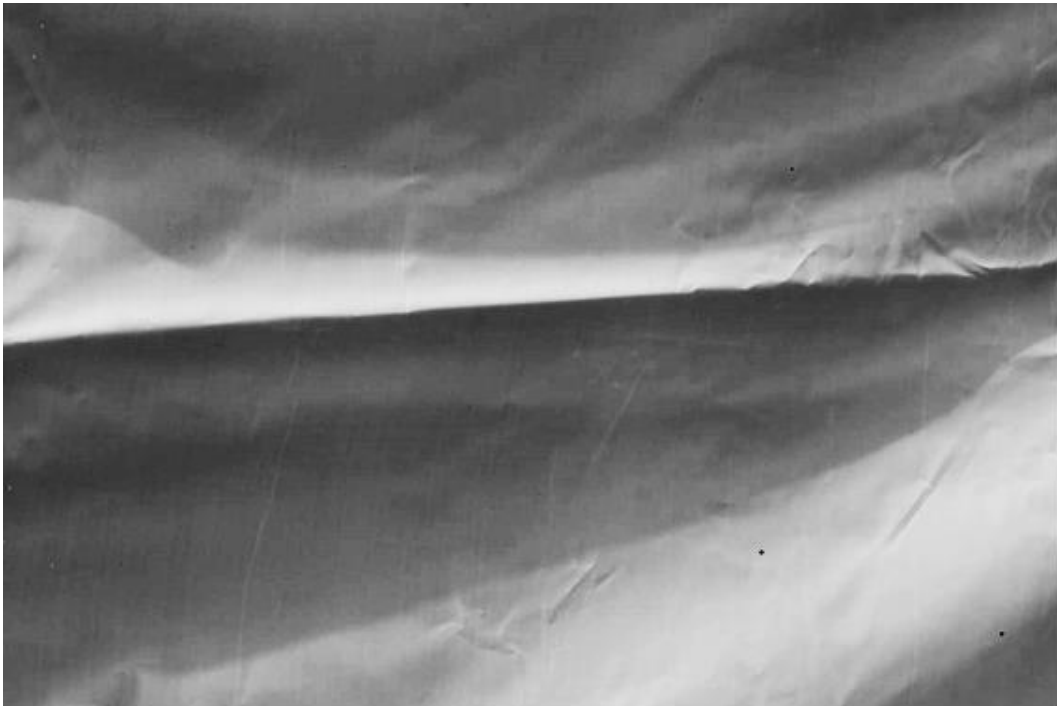
**Fig. 2** Typical crease, image post processed [DEKRA].

Creases are ridges in a material that are caused by a fold or wrinkle being placed under pressure.

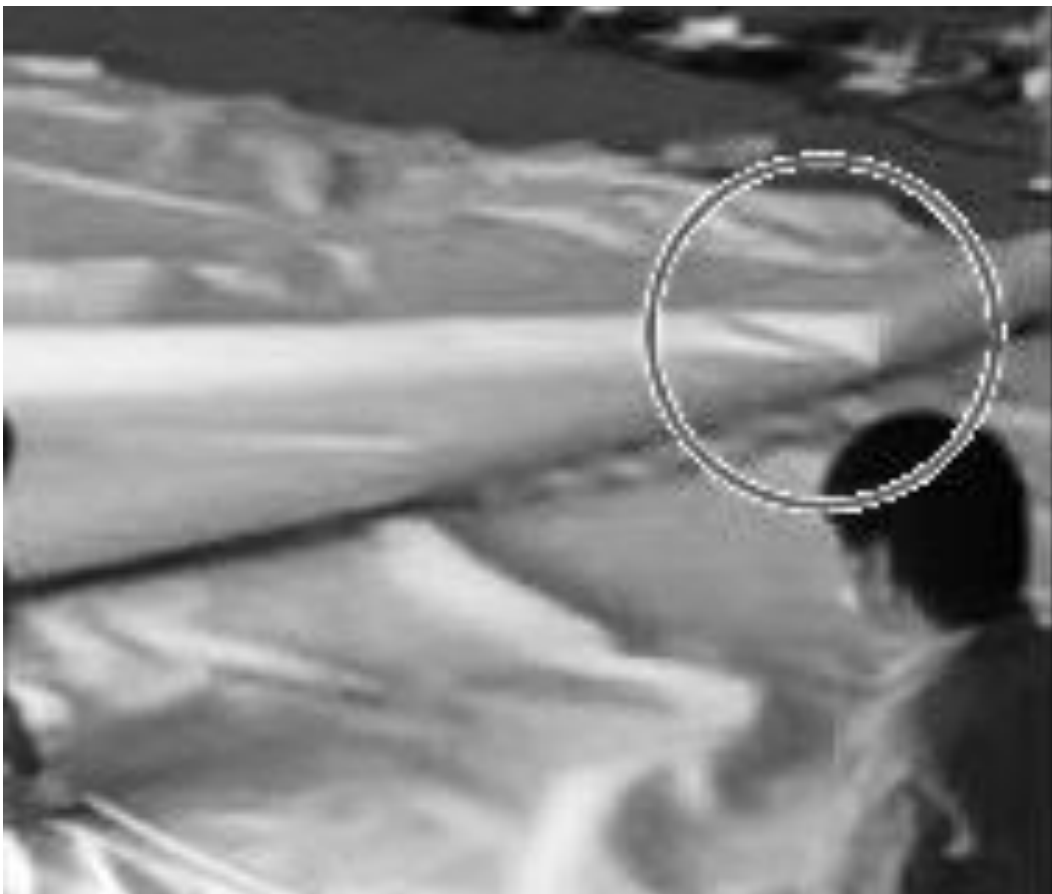
**Fig. 3** Creation of a running fold [DEKRA].

Another type of folds occurring during manufacturing is the running fold. It happens when an unloaded crease — often perpendicular to a loop — is moving, e.g., by pulling the material parallel to the loop (compare Fig. 3).

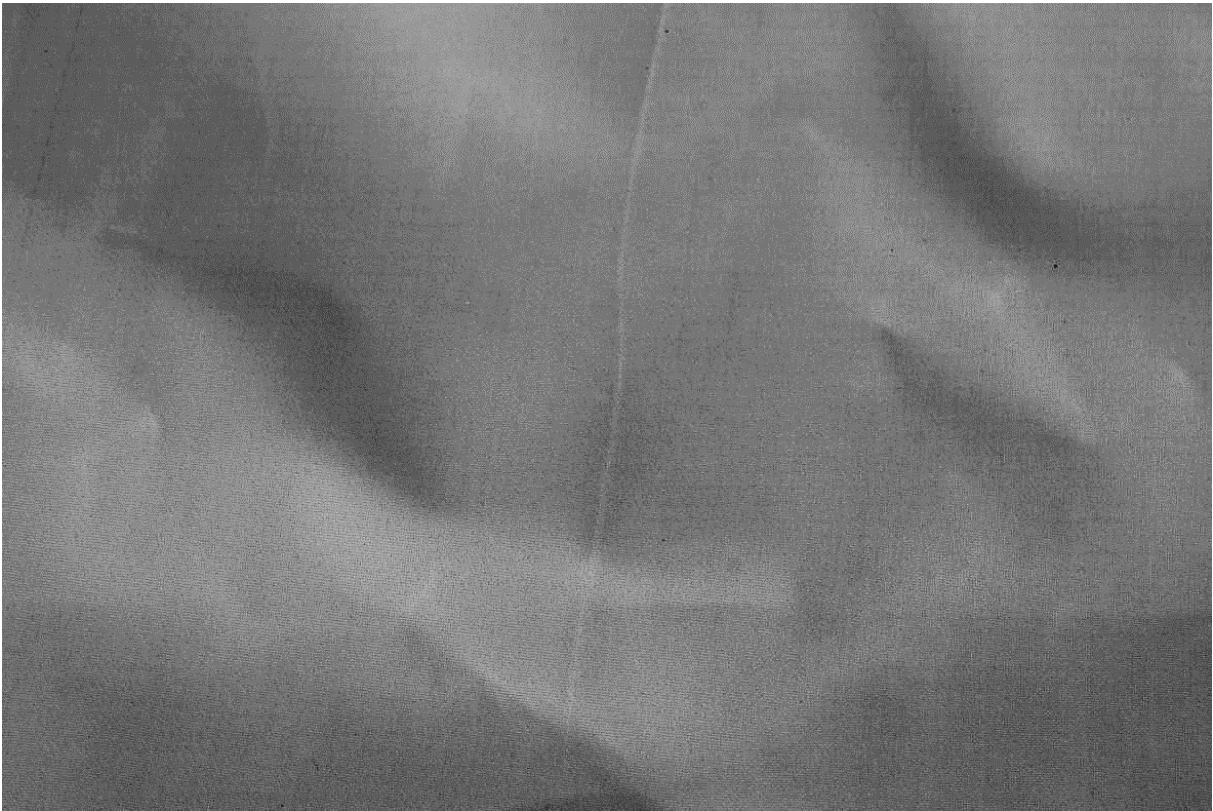
**Fig. 4** Rolling fold, image post processed [DEKRA].

The effect may be seen in the following Fig. 4.

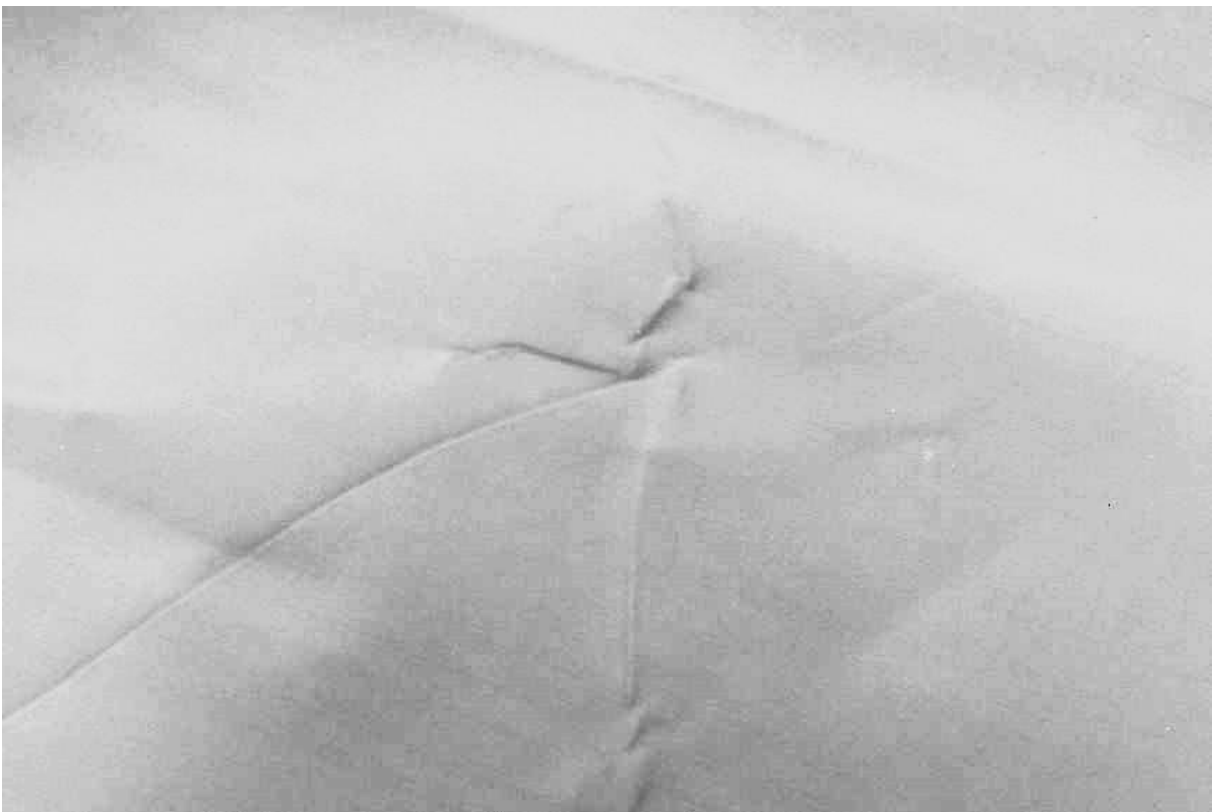
**Fig. 5** Running double crease in the center of the picture and running folds from the center to the left corner and bottom, image post processed [DEKRA].

A running double crease happens as soon as local double fold is torn out when moving the panel. This may happen over a great length and may harm the glass

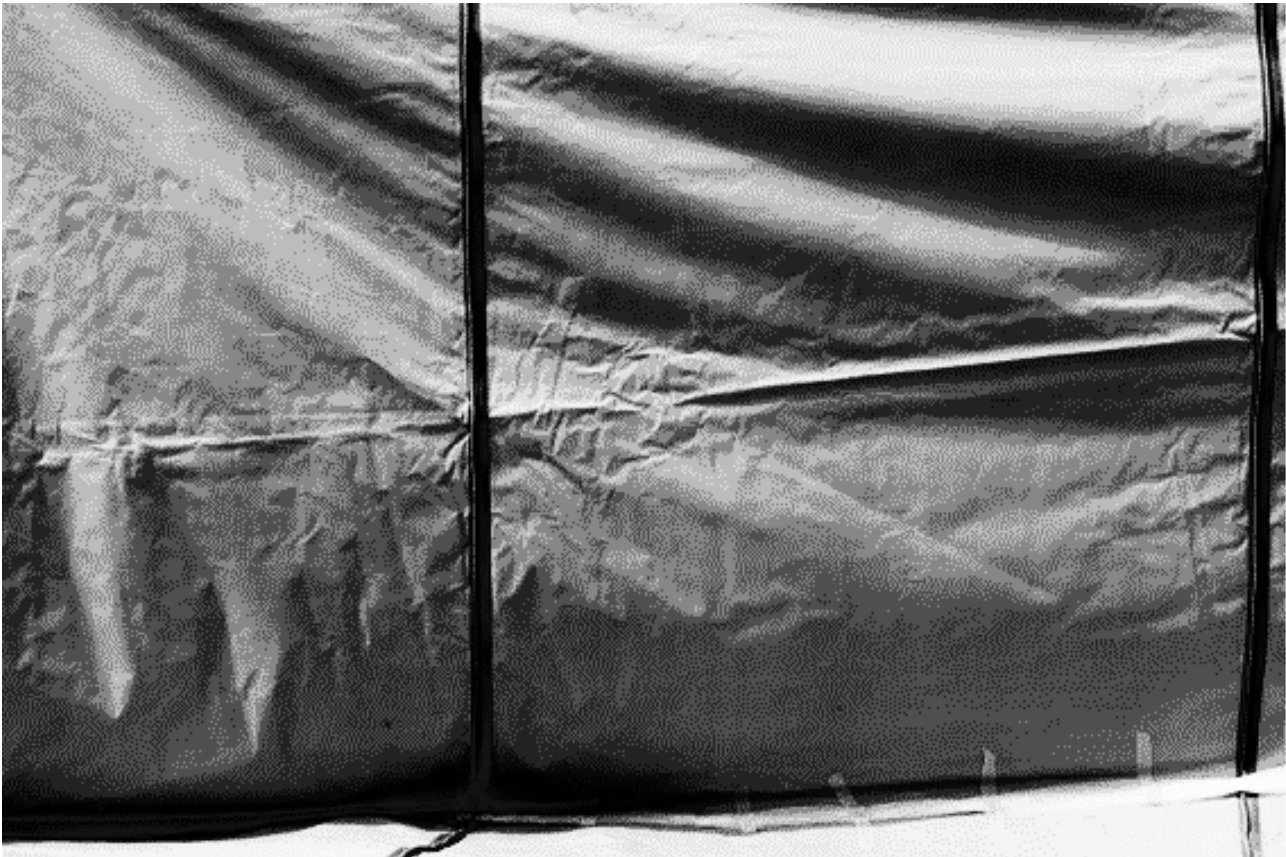
Fig. 6 Typical creases resulting from packing, image post processed [DEKRA].

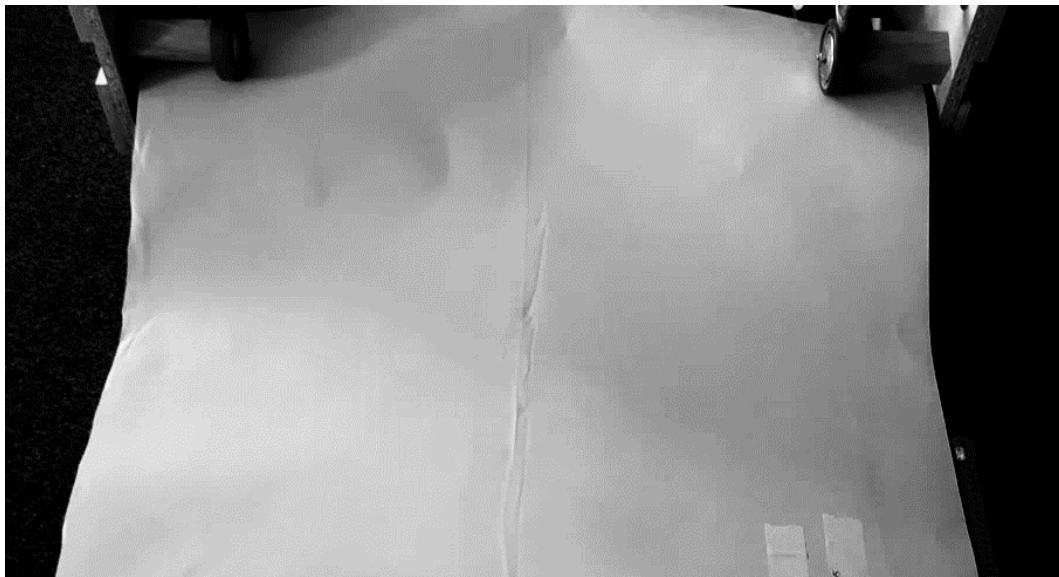
**Fig. 7** Application of running folds according to DEKRA method “Running fold” [DEKRA].

For the simulation of running folds DEKRA has designed an apparatus which creates the same folds as detected during inspections. Comparative tests between materials damaged by running folds taken from manufacturing and materials where the running fold has been applied in the running fold device have been compared and showed reliable results.

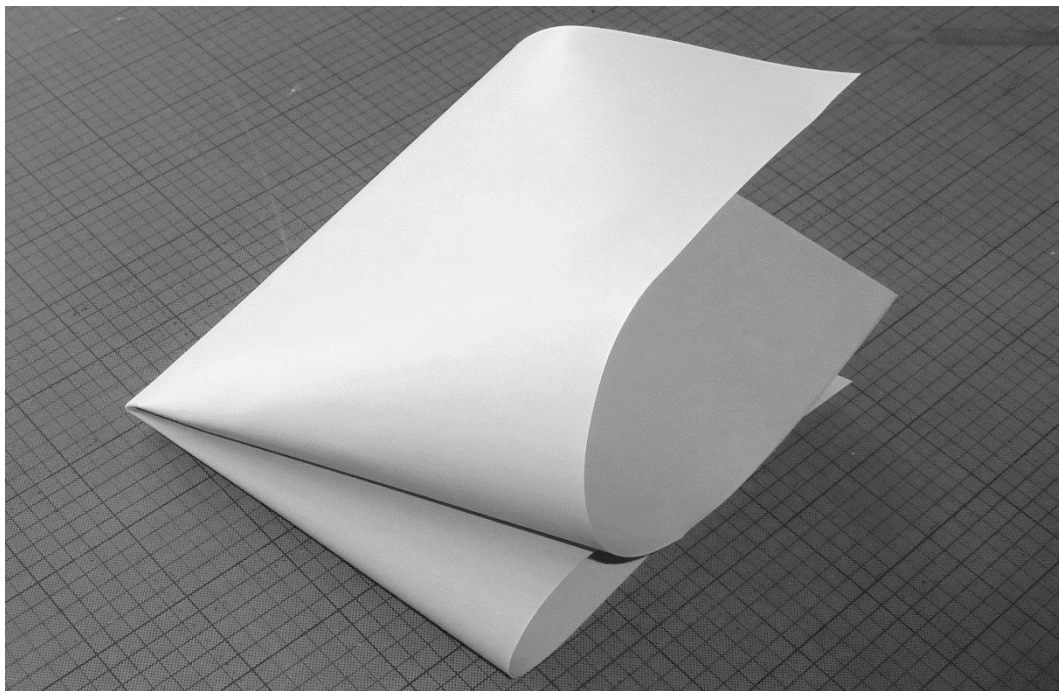
**Fig. 8** Application of running double crease, DEKRA method “Running double crease” [DEKRA].

Running double creases are produced by folding the material twice producing a sharp edge. This sharp edge is then torn out along the first fold. The glass fibres are sharply creased and might crack, “white cracks” occur.

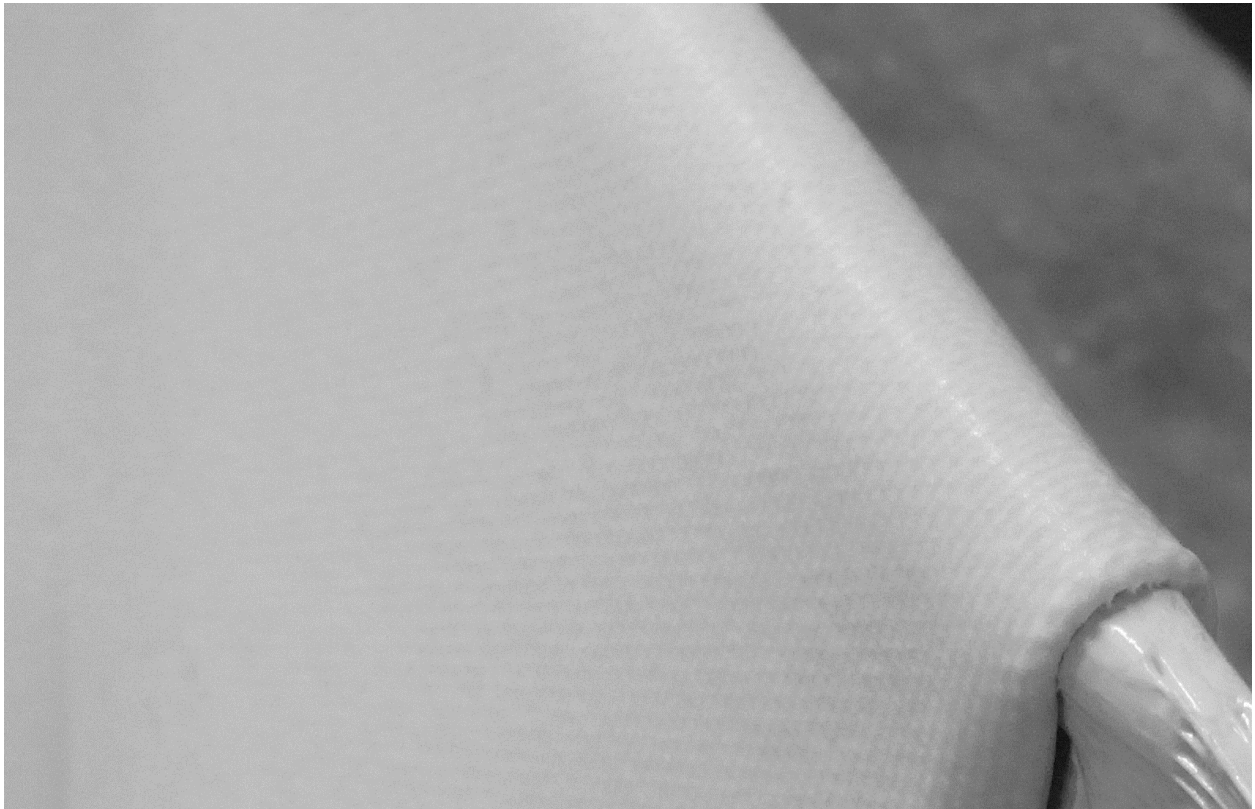
**Fig. 9** Application of running double crease, DEKRA method “Running double crease” [DEKRA].

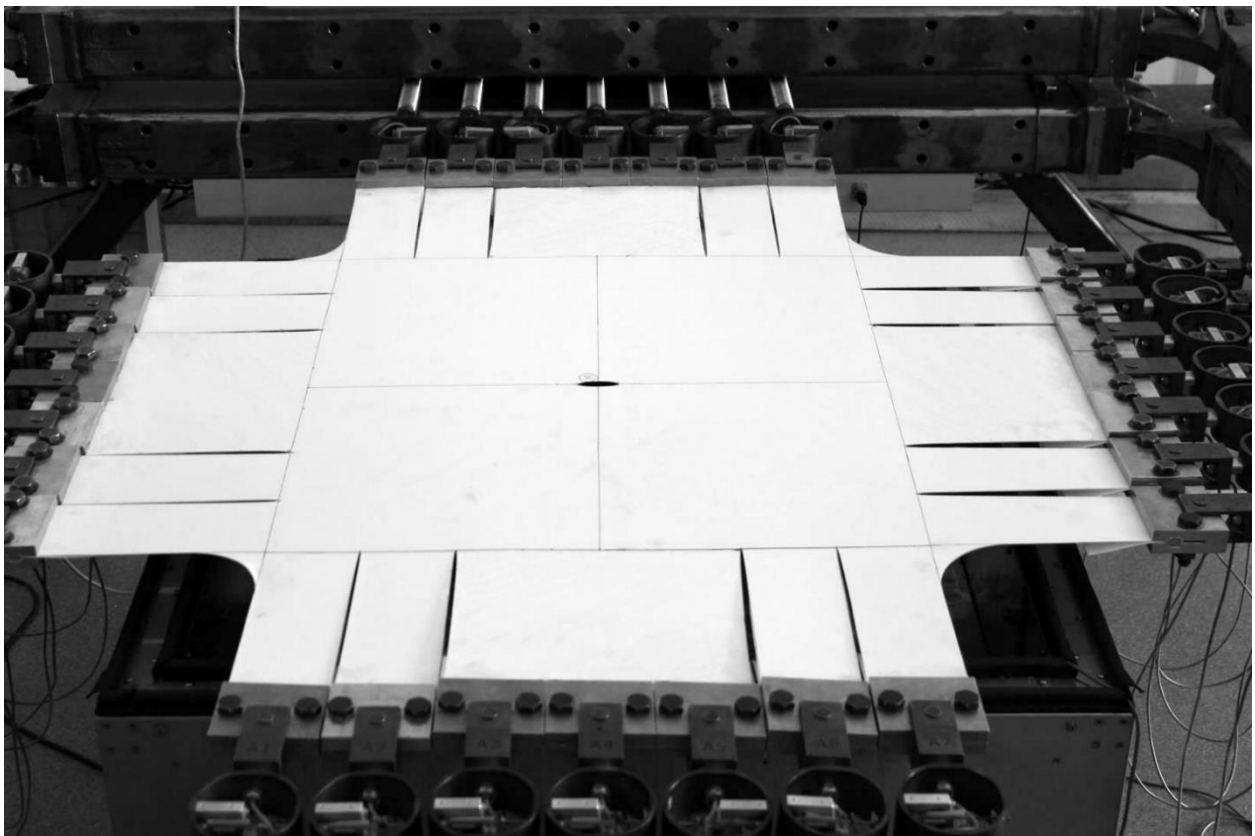
**Fig. 10** Biaxial tear propagation test at DEKRA [DEKRA].

The execution and evaluation of biaxial tear propagation tests have been described in Refs. [6-9]. Typically tear propagation were tested with applied cuts of different length in the centre of a biaxial sample

or as wide panel tear tests. An experimental set up with a 70 cm by 70 cm wide sample is shown in Fig. 10.

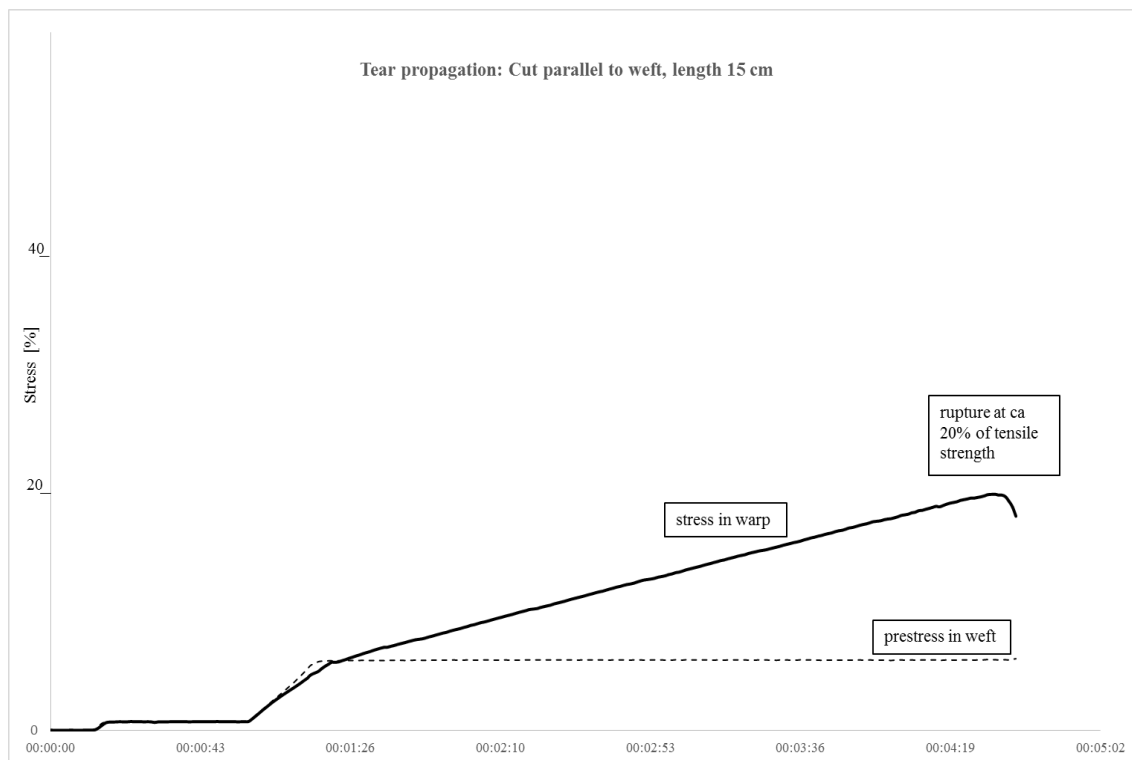
**Fig. 11 Results of biaxial tear propagation test with a 15 cm wide cut for material A [DEKRA].**

Example results for a 15 cm wide cut parallel to fill direction are shown in Fig. 11.

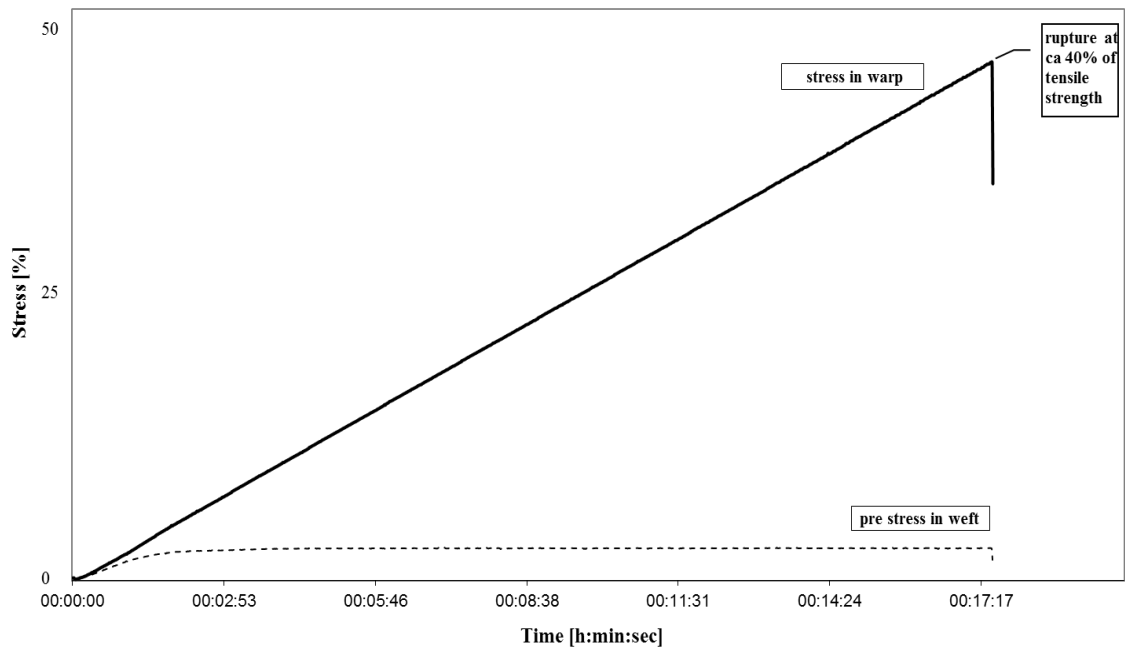
**Tear propagation: Running double crease parallel to weft, length 15 cm**

**Fig. 12 Results of biaxial tear propagation test with a 15 cm wide running double crease for material A [DEKRA].**

The procedure of biaxial tear propagation tests on folds is similar to the one described above. Here instead of a cut a damage with a defined fold will be applied in the centre of the sample. Then the membrane stress perpendicular to the damage will be increased until the failure of the sample.

Comparing the test methods one can state that the tear propagation for cuts of the same length as the running creases starts at lower fabric stresses. It starts slowly with one thread cracking after the other before the total rupture happens. Contradictory to this the rupture of the sample with an applied crease happens suddenly without advance notice. There is no need to emphasize that this might be very critical for a structure in use. The difference of breaking strength is not so

much influenced by the length of the damage in the tested range between 5 and 15 cm length (between 40 and 45% of uniaxial ultimate tensile strength) as it is typically for cuts.

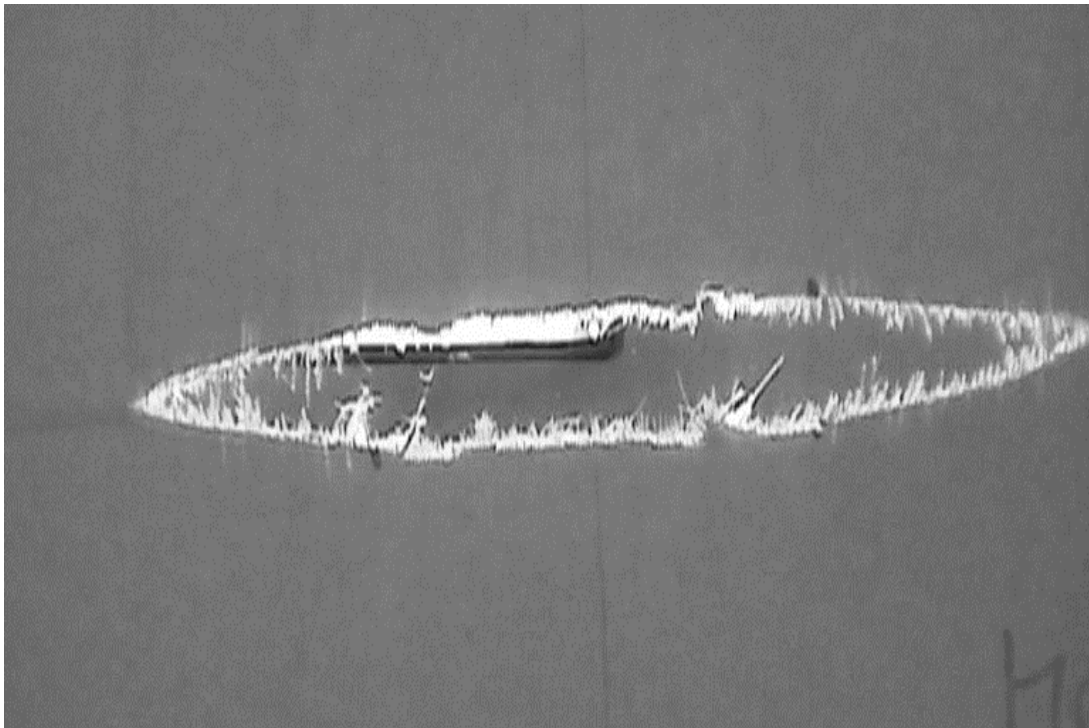
**Fig. 13 Suddenly propagating tear [DEKRA].**

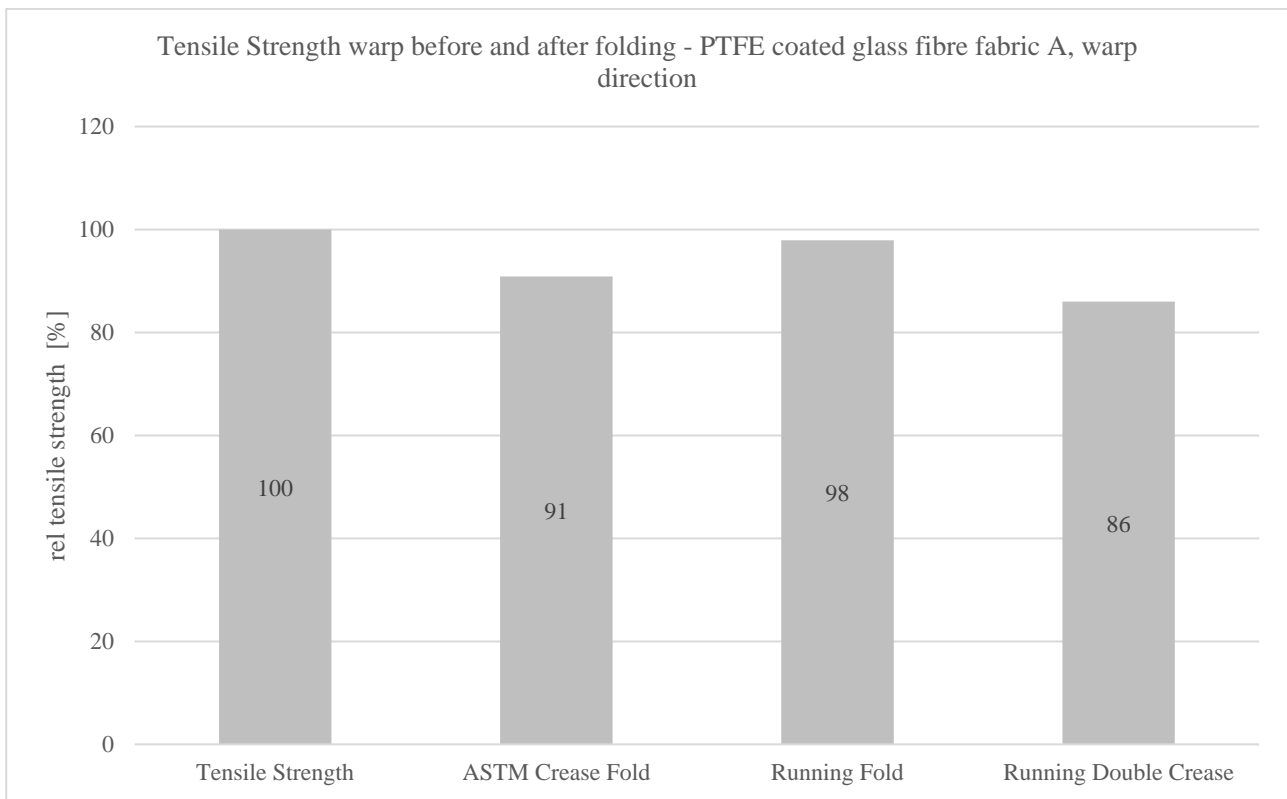
**Fig. 14** Comparison of relative tensile strength before folding (100% equal to 5% fractile according to DIBt guideline) and after folding, PTFE coated glass fibre fabric, material A in warp direction [DEKRA].

The breaking strength of different PTFE coated glass-fibre materials has been tested on 10 cm wide strips following the procedure of ISO 1421. To other sets of samples the three test methods described in here have been applied (ASTM Crease fold, running fold and running double crease). The 5%-fractile of the initial breaking strength of the material has been set to 100% and the decrease after folding has been expressed by the rel. strength compared to the initial strength.

The decay in strength depends on material type, direction, producer and sometimes even on a smaller measure on batches.

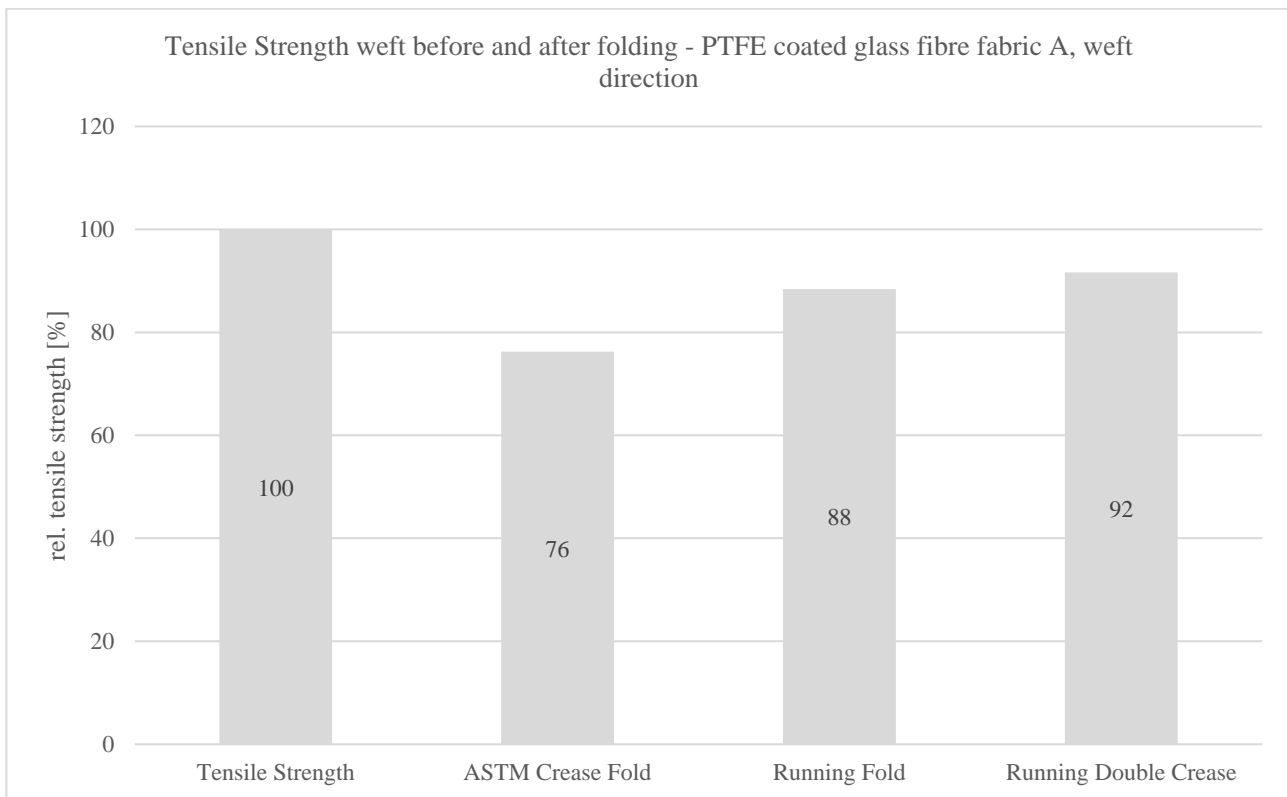
**Fig. 15** Comparison of relative tensile strength before folding (100% equal to 5% fractile according to DIBt guideline) and after folding, PTFE coated glass fibre fabric, material A in weft direction [DEKRA].

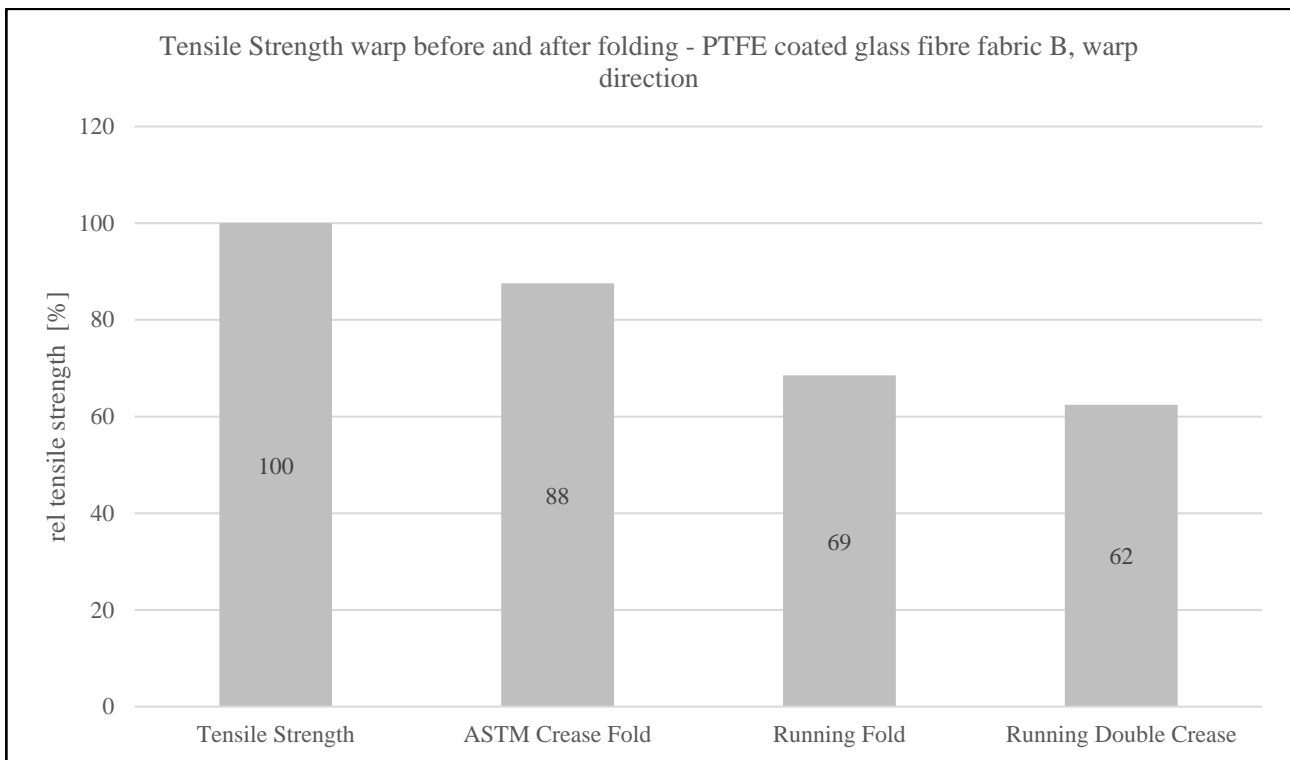
**Fig. 16** Comparison of relative tensile strength after folding compared to initial strength, PTFE coated glass fibre fabric, material B, warp direction [DEKRA].

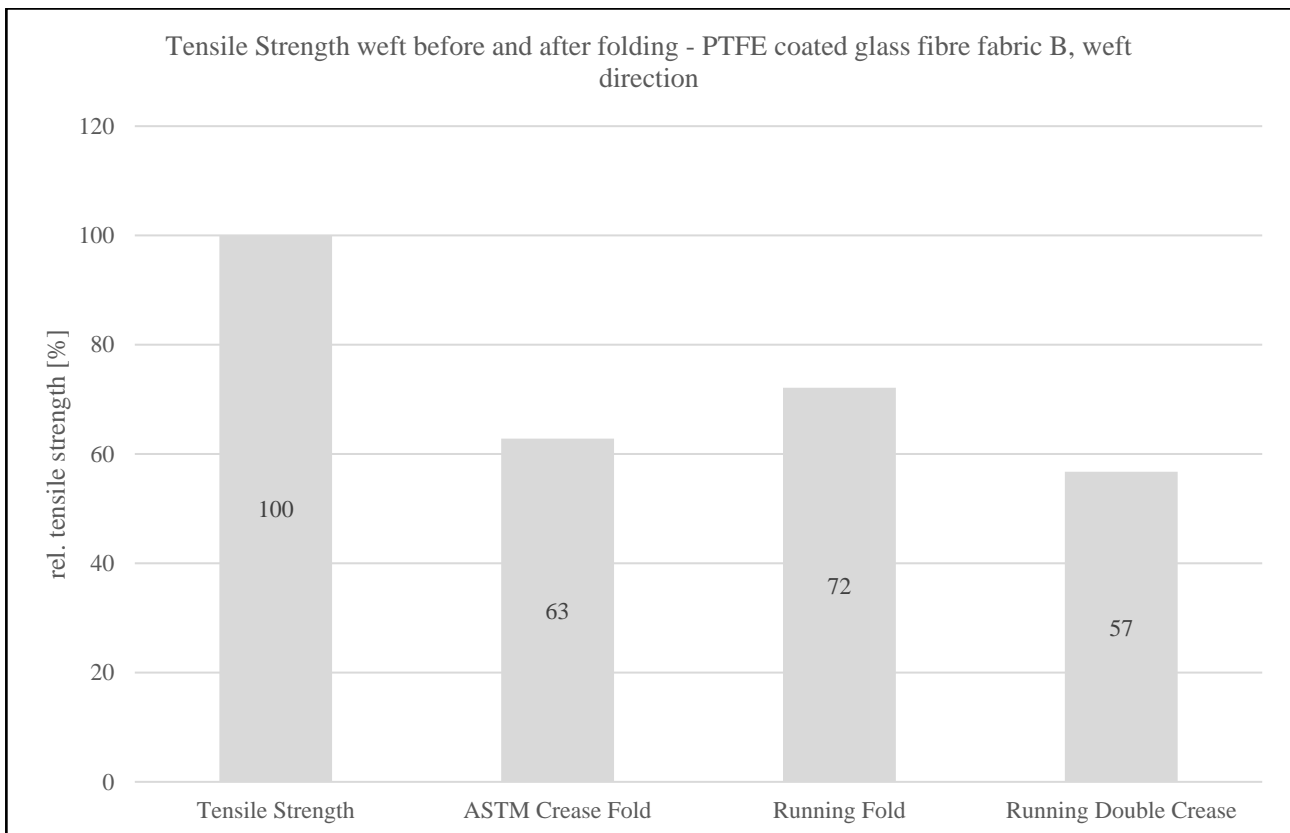
**Fig. 17** Comparison of relative tensile strength after folding compared to initial strength, PTFE coated glass fibre fabric, material B, weft direction [DEKRA].
